Dilapidation Surveys

The good, the bad and the ugly

Example 1

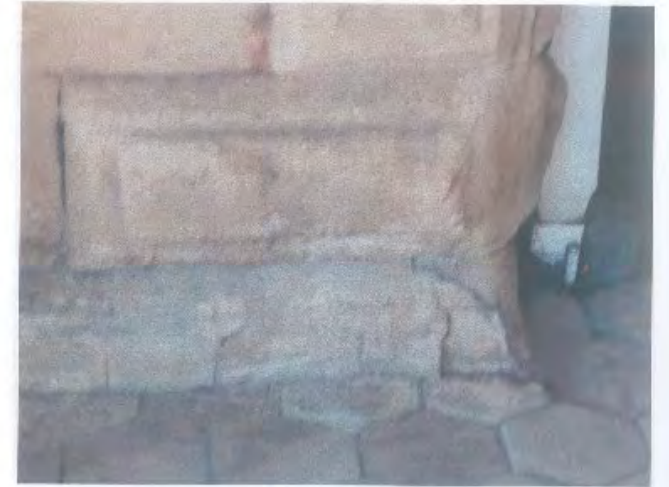
At the north western corner of the residence there is fretting of the sandstone at foot path level. The fretting is illustrated in photograph P1 and is to the lower courses of block work.

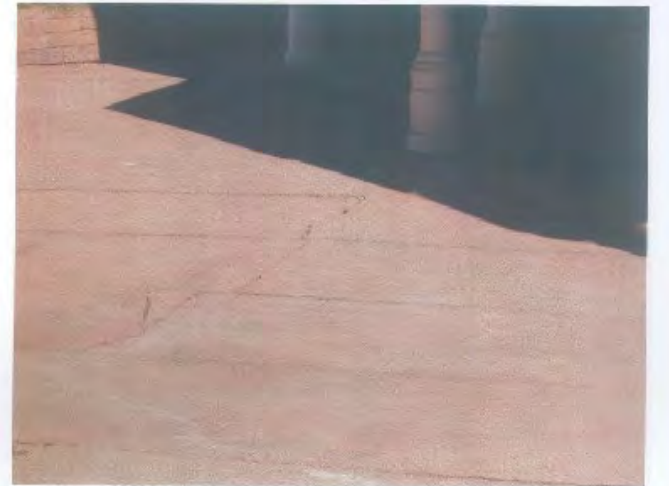
P2

At ground level adjacent to the residence there is concrete paving which is now deformed due to heaving of the soils. The heaving is typically illustrated in photograph P2.

At ground level adjacent to the residence there is concrete paving which is now deformed due to heaving of the soils. The heaving is typically illustrated in photograph P2.

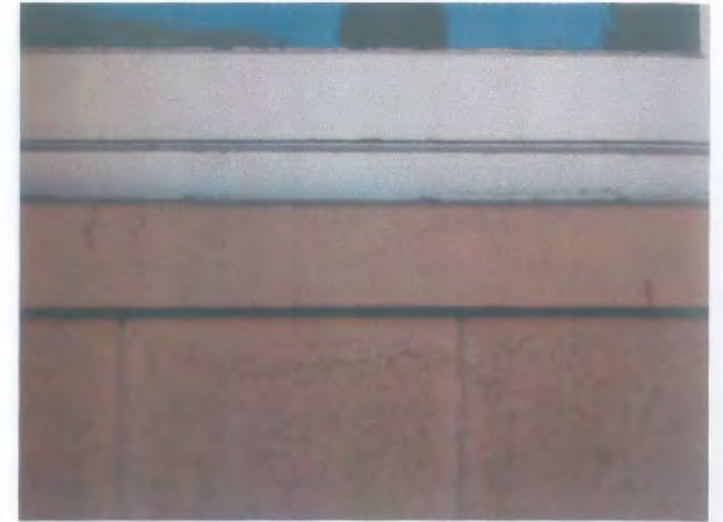
P3

At the window sill it is noted that there separation beneath the sill as illustrated in photograph P3.

At the window sill it is noted that there separation beneath the sill as illustrated in photograph P3.

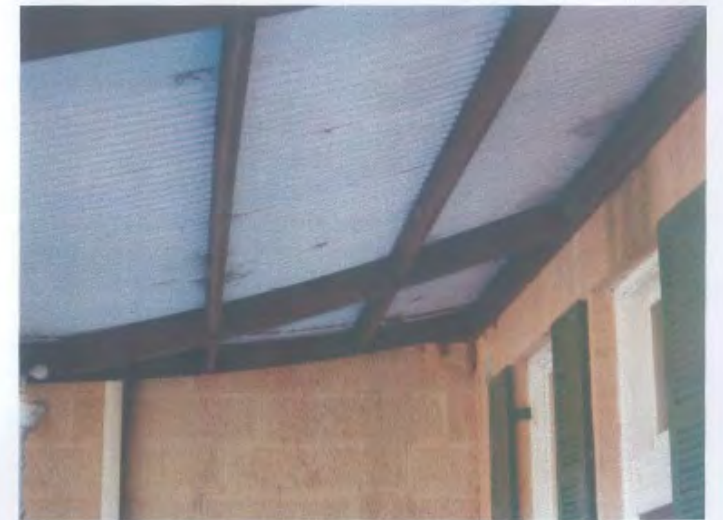
P4

Across the east elevation it is noted that there is bowing to the rafters to the verandah as illustrated in photograph P4.

Across the east elevation it is noted that there is bowing to the rafters to the verandah as illustrated in photograph P4.

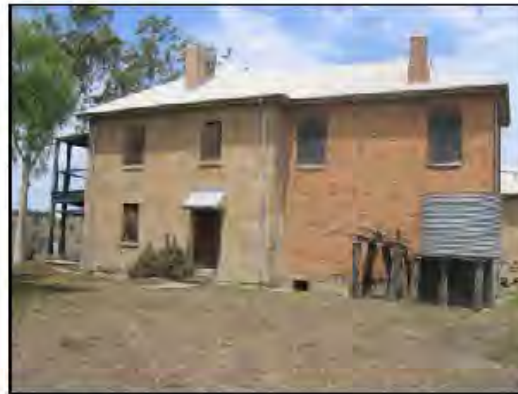
Figure 19- Western Elevation

Brick Addition:

- o Sandstock brickwork Colonial bond wall. Evidence of fretting and cracking in brickwork at lower level of wall.
- o Sandstone block foundation, missing one block, making an entry to the sub floor.
- o Sandstone blocks also spalling.
- o Two symmetrically placed double hung sash windows at upper level with stone lintel and brick soldier course lintel.
- o Three vents in wall, two on lower level, one on upper level.
- o Large crack in brickwork between northern window and joint of two buildings.
- o Movement joint between the two buildings has previously been closed by metal trim.
- o Timber fascia on eaves has a broken board at southern end of wall.

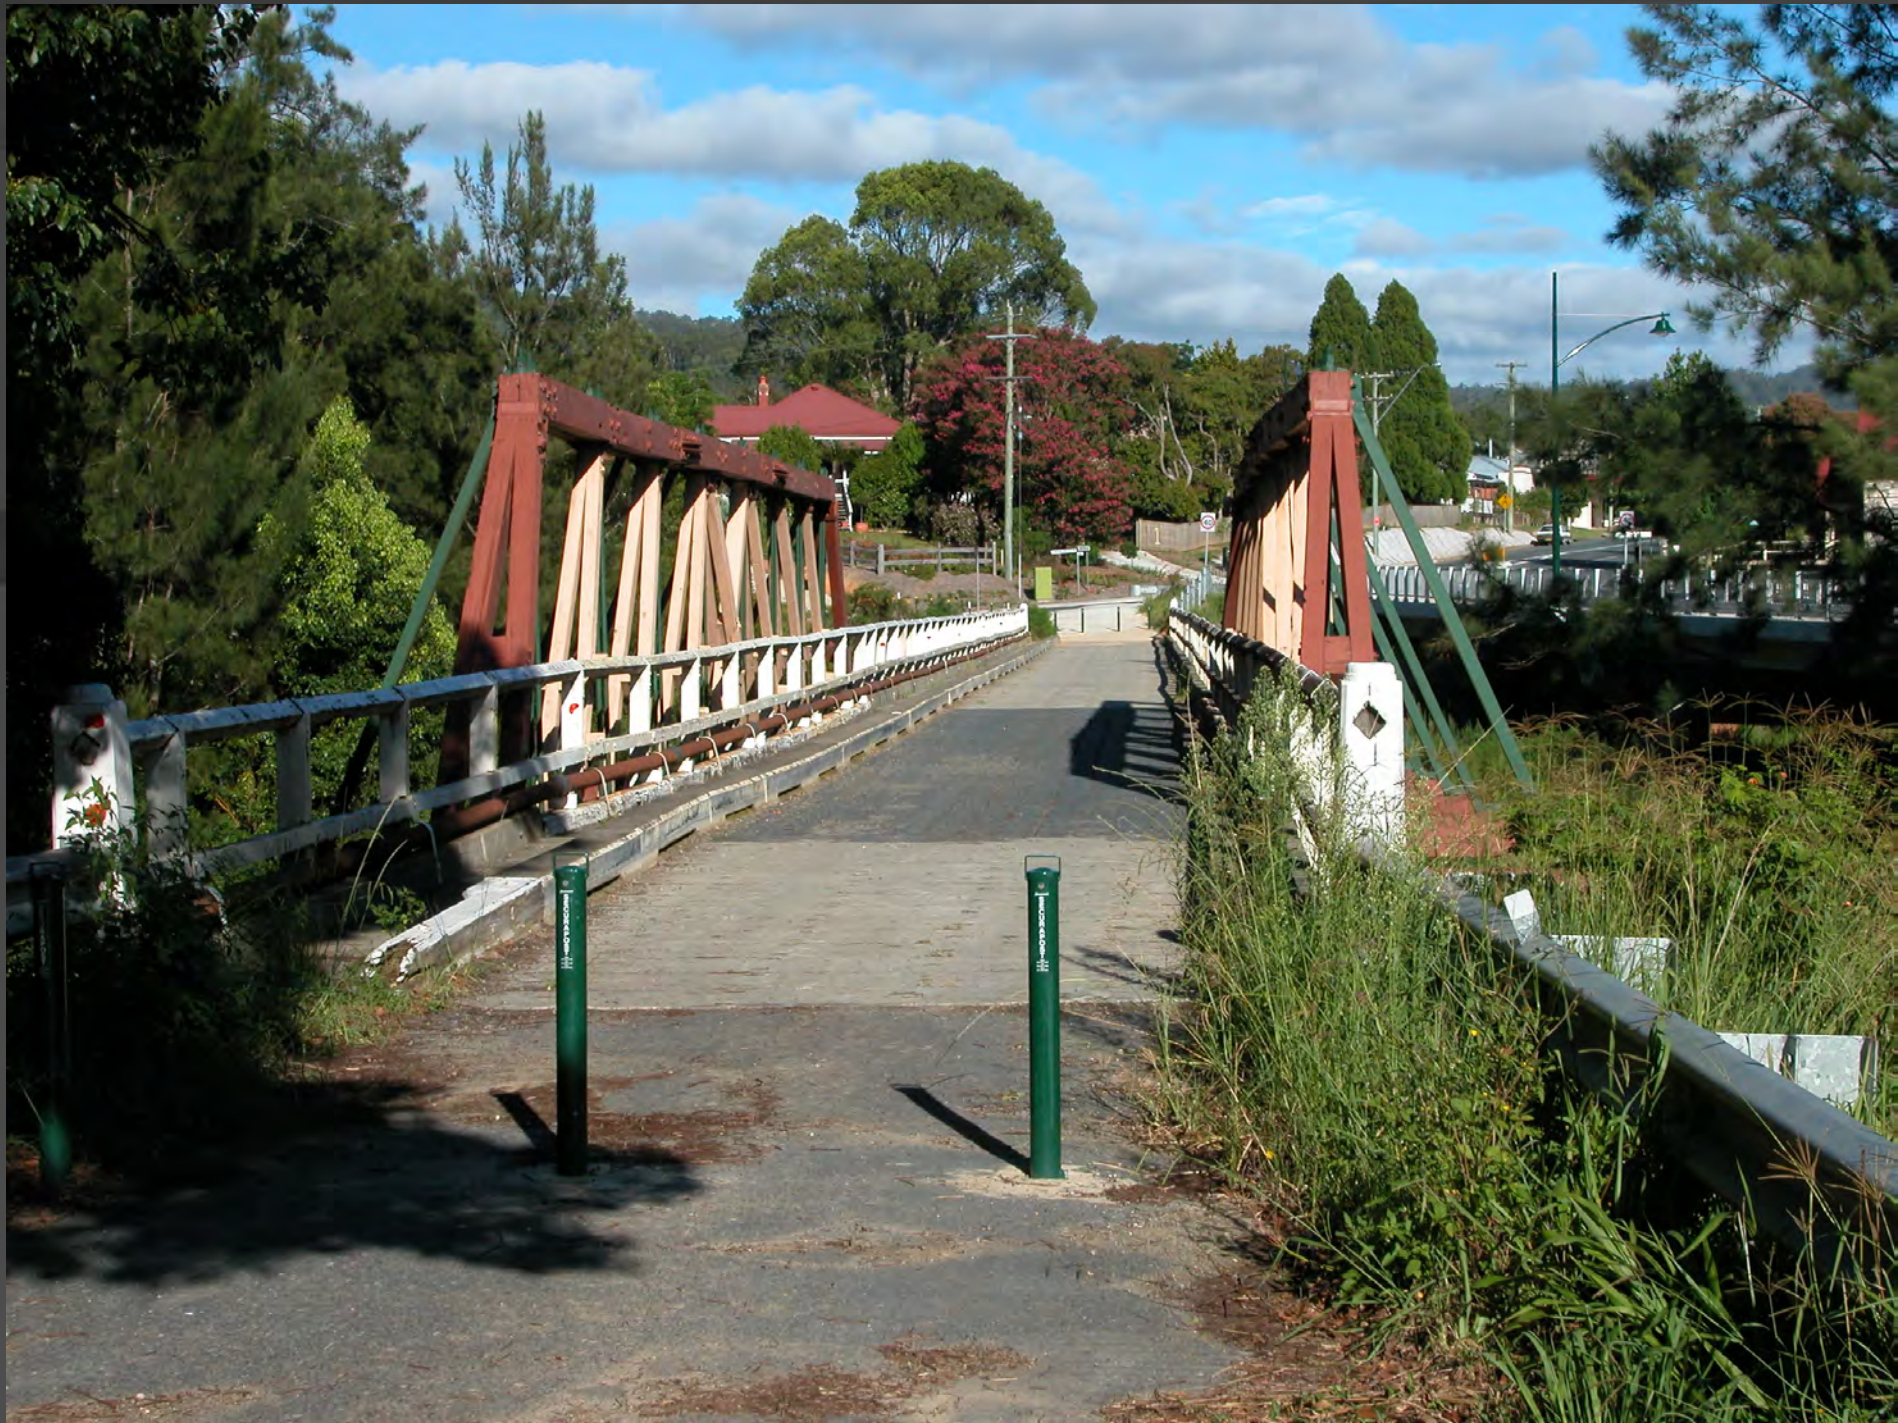
An Allan Truss bridge
